# Axial Response of Hemp-Fiber Composite Tube under Quasi-Static Compression and Impact Crushing

## ABSTRACT

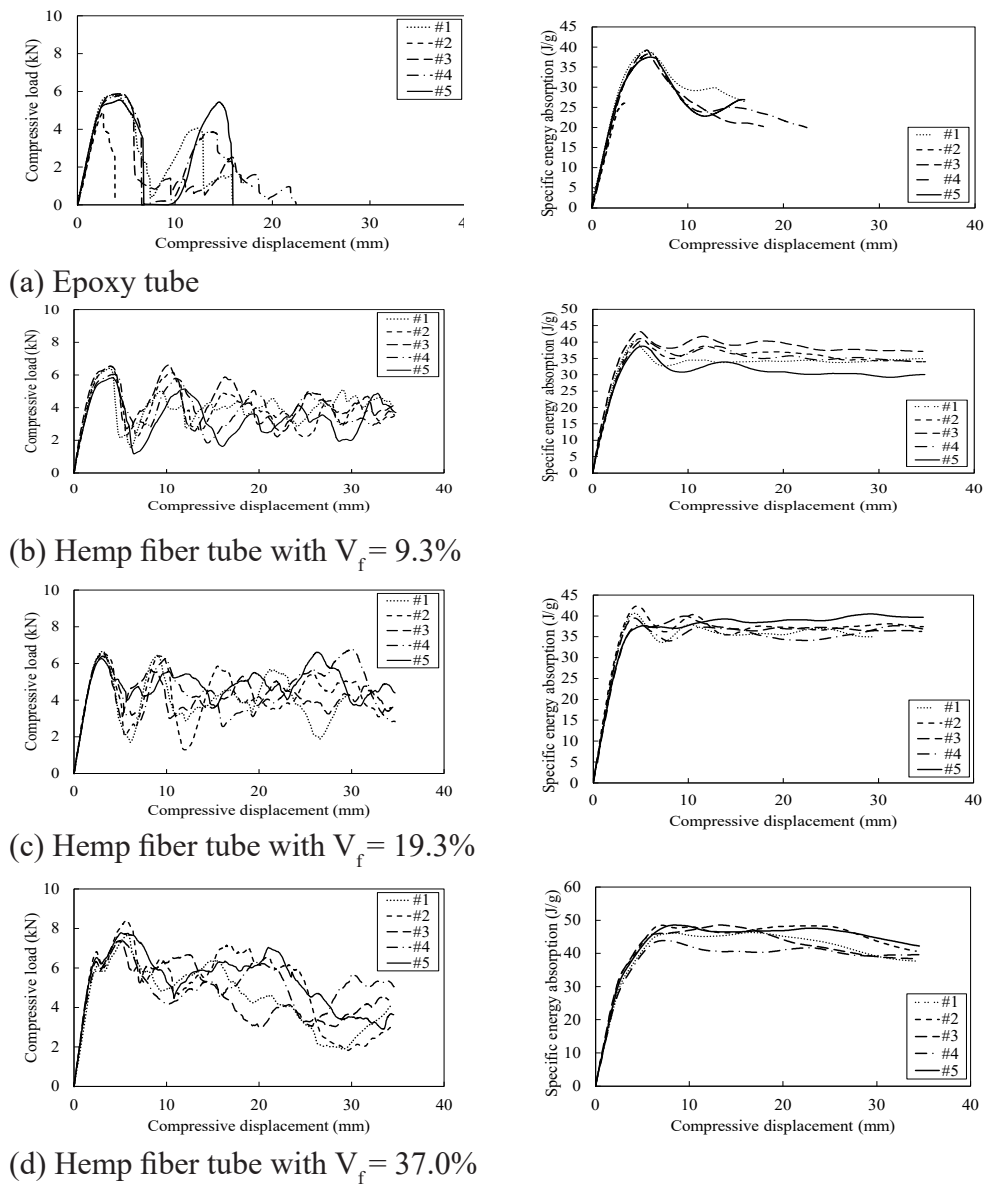
**Figure 1.** Variation in compressive load and specific energy absorption with applied compressive displacement under quasi-static test.

The compressive load-displacement responses and the corresponding energy absorptions of epoxy and hemp-fiber specimens are plotted in Figure 1. At the beginning, the load was sharply increased due to the axial strain resistance of the tube. Then, the load was slowly raised before reaching the initial peak load. At this point, the bevel trigger at the top end was progressively crushed in the axial direction which let the load decrease. Next, the load gradually increased and dropped again due to the failure mechanism of the tubes. The load increased and dropped in this pattern throughout the test. For epoxy,

the failure behavior was brittle fracture that results in catastrophic failure. Its surface was broken and the test never reached 35 mm in compressive displacement, as shown by the load-displacement curve in Figure 1(a) and by the broken specimen in Figure 2(a). The maximum compressive displacement of the epoxy tube was 24.4 mm, while the minimum was 3.9 mm. For hemp fiber specimens, the bevel trigger was crushed to failure as shown in Figures 2(b) to (d) at compressive displacements of 3 mm, 5 mm and 10 mm, respectively. Next, axial delamination was found and growth in the axial direction, followed by bending of the tube surface, which is called frond bending as shown in, for example, Figure 2 (b) at compressive displacement of 6 mm and 18 mm. The hemp fiber specimen after complete compression also showed progressive failure. This failure behavior can absorb high energy during compression.

Figure 1 also presents the variation in specific energy absorption along the compressive displacement using equation 3. It was found that the epoxy specimen cannot absorb the compressive energy throughout its length because of its catastrophic failure, especially for specimen no. 2. The hemp fiber specimen can absorb higher energy and longer displacement than epoxy. At 35-mm displacement, the average specific energy absorption of epoxy was 9.95 J/g, and for 9.3%, 19.3% and 37.0% hemp fiber tubes it was 34.09 J/g, 37.06 J/g and 39.73 J/g, respectively.

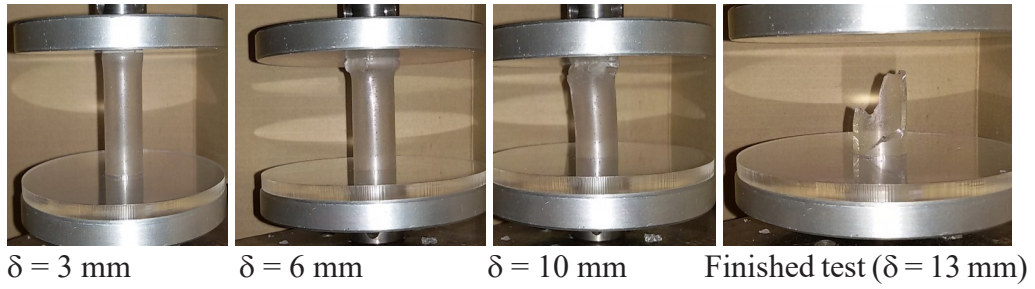
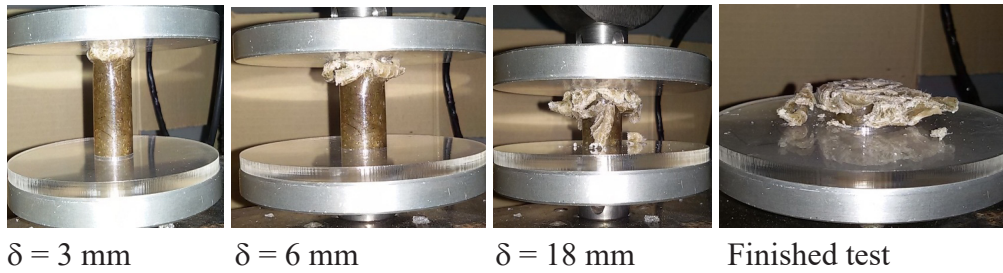
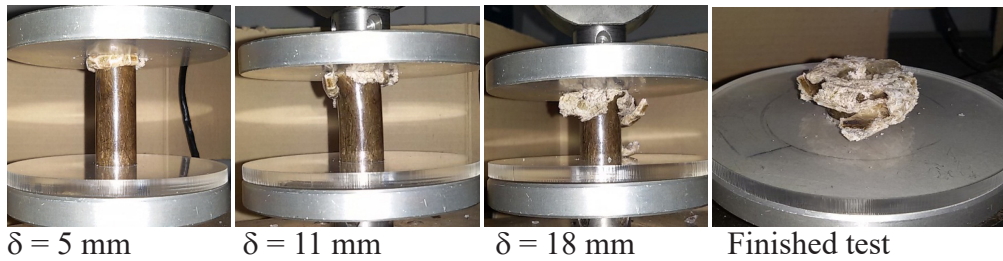
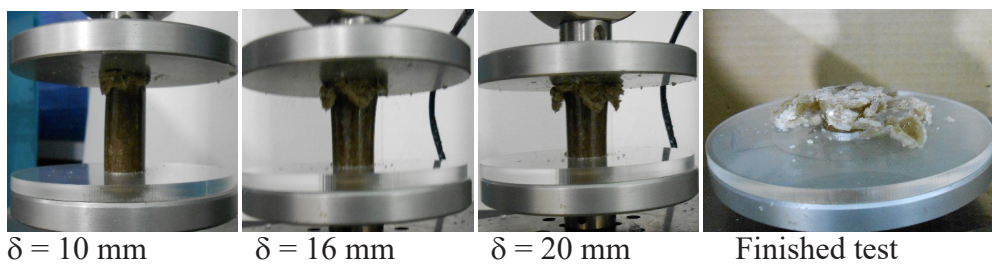
(a) Epoxy tube

(b) Hemp fiber tube with  $V_f = 9.3\%$

(c) Hemp fiber tube with  $V_f = 19.3\%$

(d) Hemp fiber tube with  $V_f = 37.0\%$

**Figure 2.** Failure mechanism of epoxy and hemp fiber tubes at different compressive displacements.

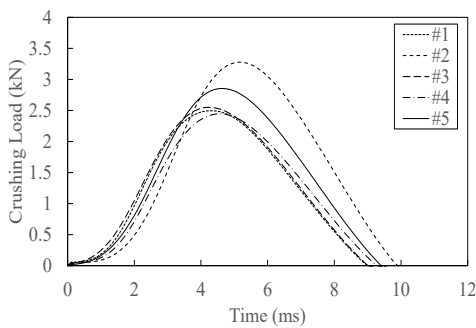
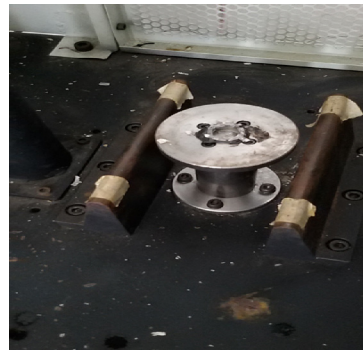
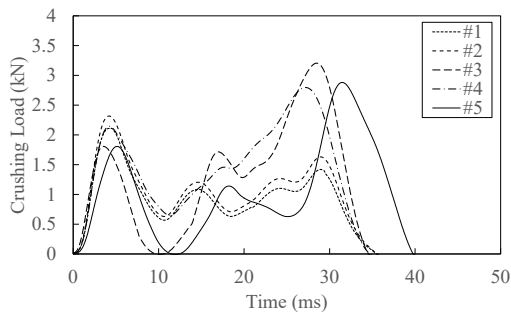
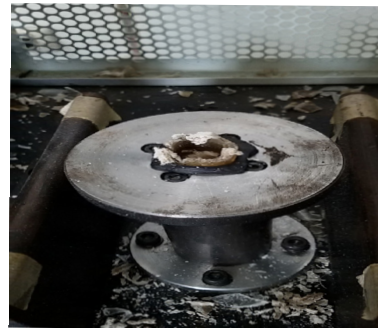
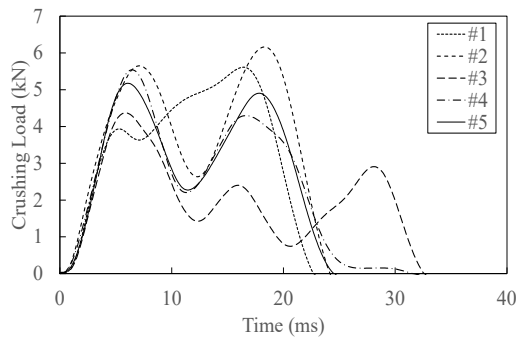
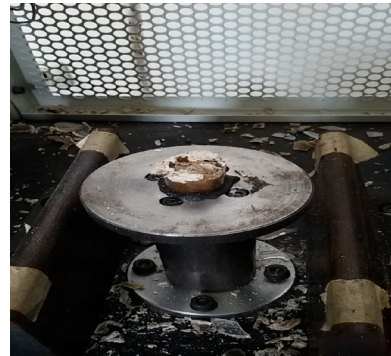
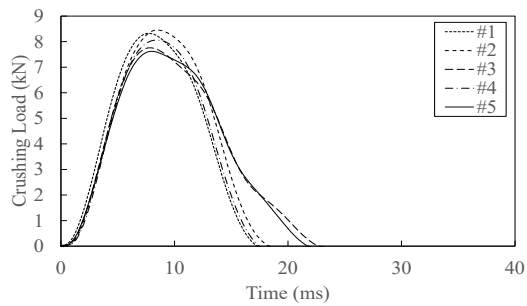
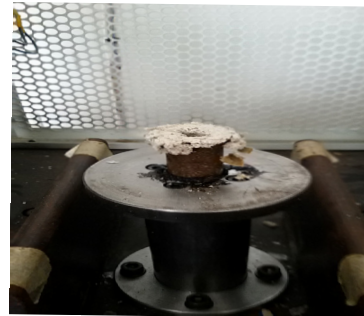
(a) Epoxy tube

(b) Hemp fiber tube with  $V_f = 9.3\%$

**Figure 3.** Impact crushing load-time response and failure behavior of epoxy and hemp-fiber tubes.

(c) Hemp fiber tube with  $V_f = 19.3\%$

(d) Hemp fiber tube with  $V_f = 37.0\%$

Crushing load and time response and finished test specimen of epoxy and hemp fiber are shown in Figure 3. The epoxy tube provided low crushing load with short crushing time response. The load sharply increased, and then it decreased due to the total failure of the specimen. Only one loop of load and time response was found for the epoxy tube and the catastrophic mode was found as shown in Figure 3 (a) in the specimen after finishing the test. For hemp fiber tubes with fiber volume fraction of 9.3% and 19.3% (see Figures 3 (b) to (c)), the load was increased and decreased due to specimen failure throughout the test. A combination of brittle and progressive failures was also found as shown. For high content of hemp fiber at 37.0% fiber content, the load sharply increased to around 7.5 kN to 8.5 kN, and then it decreased due to failure of the specimen. It can be seen in Figure 3 (d) that the specimen did not totally fail even at the highest capacity of 234 J of the impact tester.

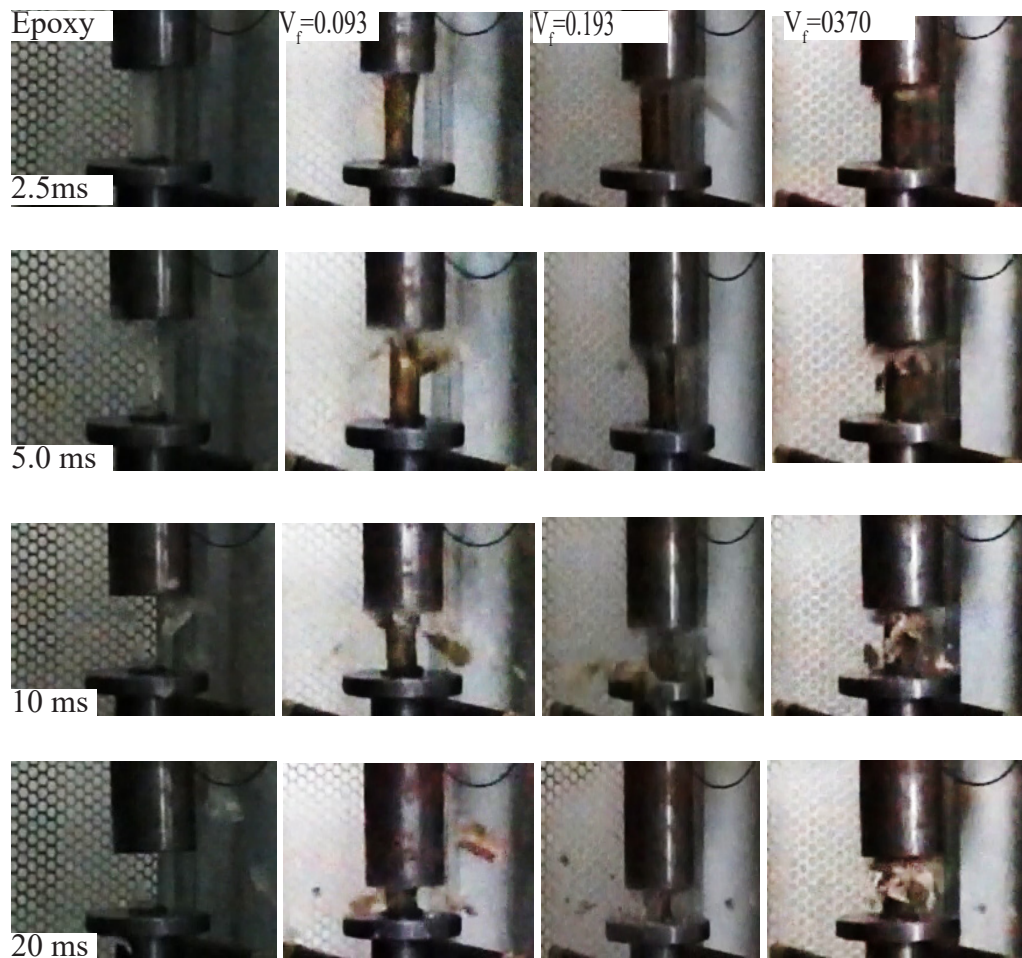
**Figure 4.** Comparison of epoxy and hemp fiber specimens at different impact crushing times.

Figure 4 presents the failure of epoxy and hemp fiber tubes at different impact crushing times. The epoxy specimen was brittle and failed totally before 10 ms of crushing time. For hemp fiber tube with fiber volume fractions of 9.3% and 19.3%, the trigger was either broken or degraded progressively as shown at times 5 ms and 10 ms. The specimen with high fiber content of 37.0% presented progressive failure at times of 2.5 ms, 5 ms, 10 ms and 20 ms. It was also found that after the test, at time 20 ms, the specimen was not totally collapsed.

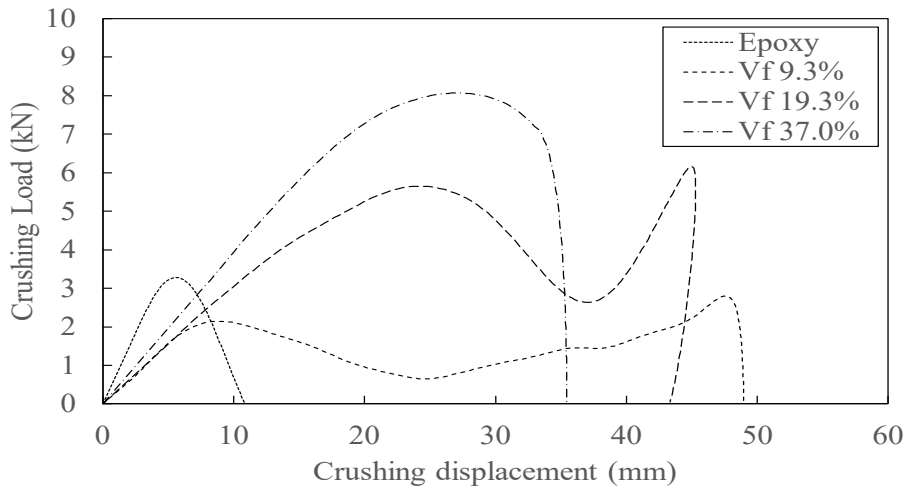
**Figure 5.** Crushing load and displacement responses evaluated by equation 5.

The absorbed energy presented in Table 1 was calculated from the crushing load and time responses using equations 3 to 5. Since the area under the curve is the deviation in velocity of the impactor, the crushing displacement can be evaluated using the equation of impulse and momentum as in equation 5. Figure 5 presents the crushing load and the corresponding displacement of epoxy and hemp fiber specimens. It can be seen that the crushing load initially increased and then decreased due to failure and may increase and decrease again before it diminishes. It is noted that, for example, the drop weight energy of the impactor for a hemp fiber specimen with fiber volume fraction of 19.3% at the height of impactor of 0.96 m is 171.95 J, and the absorbed energy or corresponding area under the calculated load-displacement curve is 168.48 J. Therefore, it can be noted confidently that the area under the crushing load and the time response can correctly estimate the absorbed energy of the sample using equations 3 to 5.

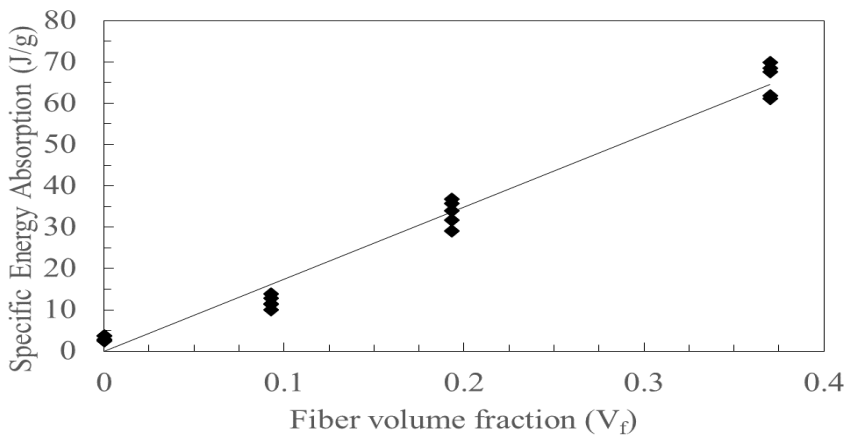
**Figure 6.** Variation in fiber volume fraction and specific energy absorption under impact crushing.

Figure 6 presents the correlation of specific energy absorption and fiber volume fraction. High fiber volume fraction results in high specific energy absorption as found in static compression. It can be seen in the chart that linear correlation of fiber content and specific energy absorption can be observed as reported by Meredith et al. (2012). Composites with higher volume fraction have less epoxy available, which reduces the energy dissipation due to epoxy cracking (Meredith et al., 2012).

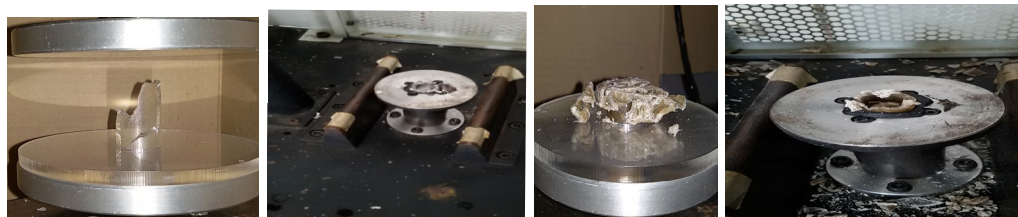
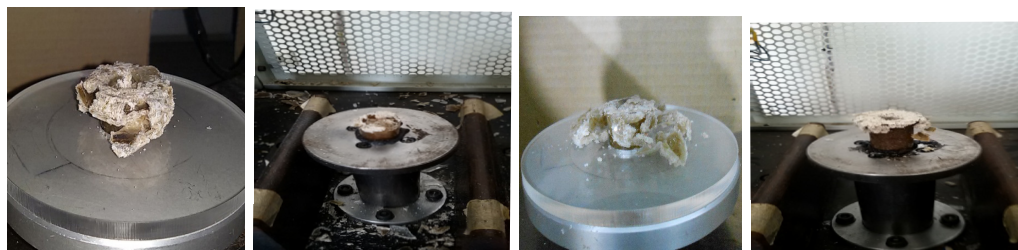
(a) Epoxy tube

(b) Hemp fiber tube with  $V_f = 9.3\%$

(c) Hemp fiber tube with  $V_f = 19.3\%$

(d) Hemp fiber tube with  $V_f = 37.0\%$

**Figure 7.** Comparison of failure behavior under quasi-static compression (left) and impact crushing (right).

The failure patterns of hemp fiber tubes under quasi-static and impact crushing are significantly different. Failure of tubes under quasi-static compression and impact crushing are compared and presented in Figure 7. Brittle fracture can be found in the epoxy tube (see Figure 7(a)), even with quasi-static compression or impact crushing. The tubes collapsed with catastrophic failure. For low reinforcement fiber tubes at 9.3% and 19.3%, the sample showed that a progressive failure in combination of splaying and fragmentation modes can be found under quasi-static test, as seen in the left of Figure 7(b) and Figure 7(c). However, tubes behaved with less ductility with a combination of brittle and ductile surfaces, even when using a low velocity of the impactor. For a high fiber volume fraction of 37.0%, the failure surface of hemp fiber tube under impact crushing, as shown in the right of Figure 7(d), revealed the splaying mode of progressive failure; an axial crack grows in the middle of the tube surface and its lamina bends inside and outside. This failure pattern is clearly seen in the tube under quasi-static compression, while the specific energy absorption under impact test was much higher than that under quasi-static test.

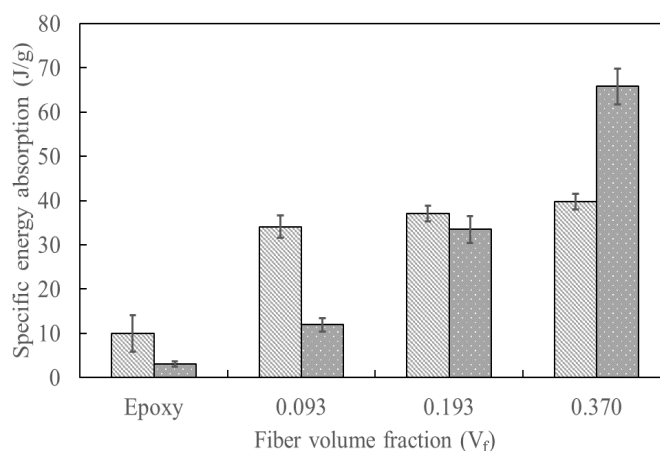
**Figure 8.** Comparison in specific energy absorption under quasi-static compression and impact crushing, error bars at  $\pm 1$  SD.

Figure 8 presents the comparison of the specific energy absorption of epoxy and hemp fiber tubes under quasi-static compression and impact crushing. It can be seen that the specific energy absorption for 9.3%, 19.3% and 37.0% hemp fiber tubes under quasi-static test were 34.09 J/g, 37.06 J/g and 39.73 J/g, while those of hemp fiber tubes under impact crushing were 11.91 J/g, 33.47 J/g and 65.76 J/g, respectively. With 9.3% of fiber content, the tube under very low speed compression presented 3 times higher specific energy absorption than that of the tubes under impact crushing. For 19.3% hemp fiber tubes, the specific energy absorptions under both loadings are in agreement. At high fiber volume fraction of 37.0%, the specific energy absorption of the tube under impact crushing is much higher than that of the tube under quasi-static compression. Due to the speed of compression, Figure 8 also shows less variation in fiber volume fraction of hemp fiber tube and specific energy absorption under quasi-static

compression. For impact crushing, a higher variation in fiber volume fraction and specific energy absorption is presented. The reason is that, under quasi-static compression, a progressive failure can be found even using composites with low fiber volume fraction, but under impact crushing, low fiber content made the tube collapse by a combination of catastrophic failure and progressive failure.
